Research Update

Western Everglades Research Center at
Corkscrew Swamp Sanctuary

June 2018

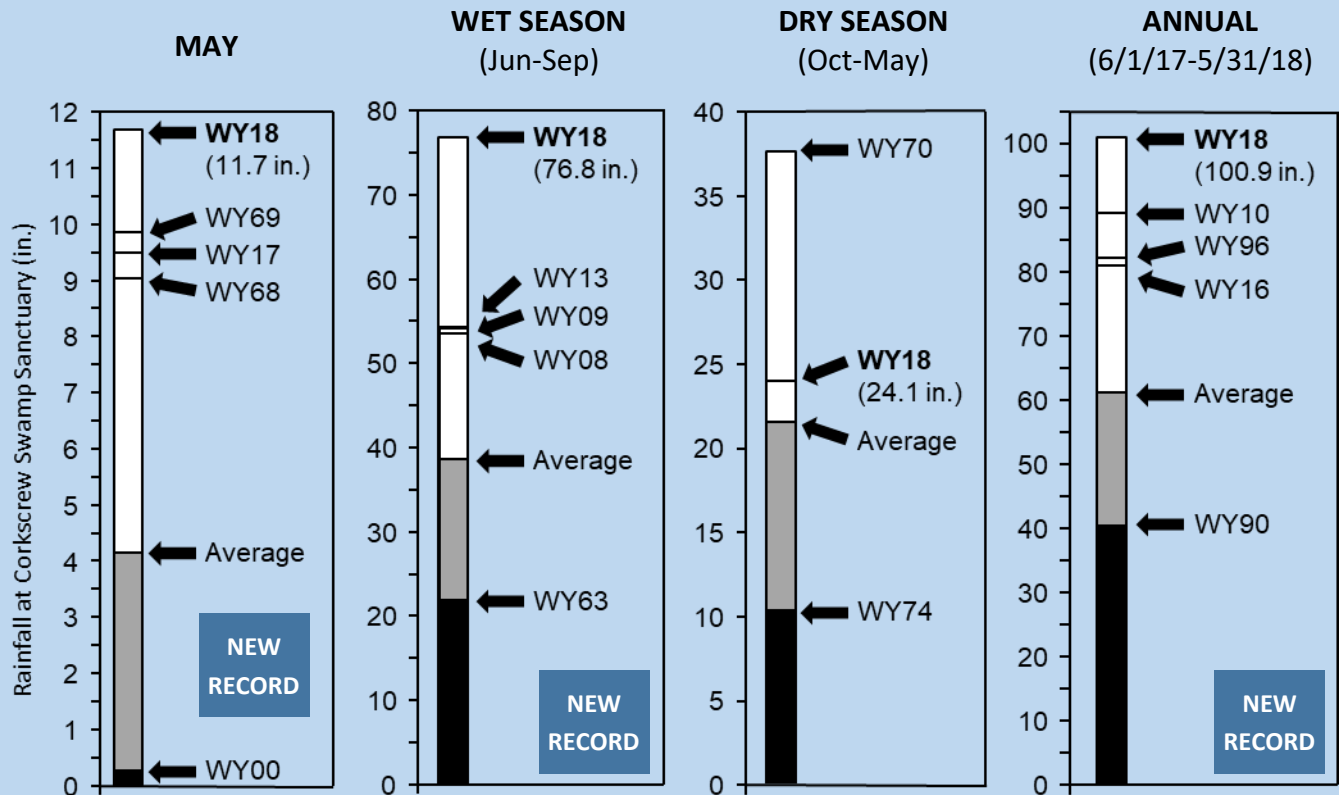
WATER YEAR 2018 (WY18¹) RAINFALL TOTALS²

Graphs indicate record high (white bar), average (gray bar) and record low (black bar). Previous record high years are also shown for May, Dry Season and Annual Rainfall.

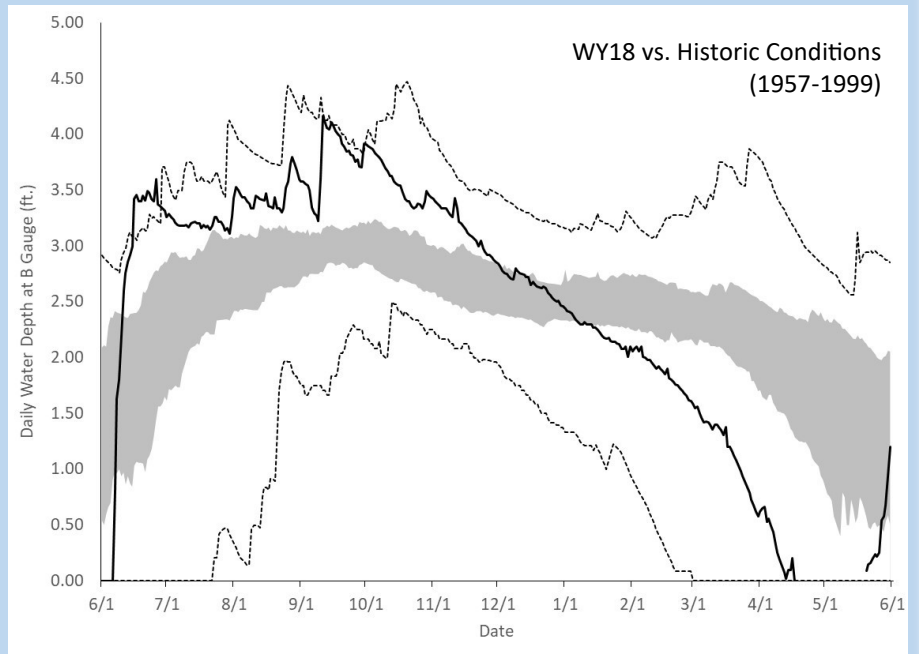
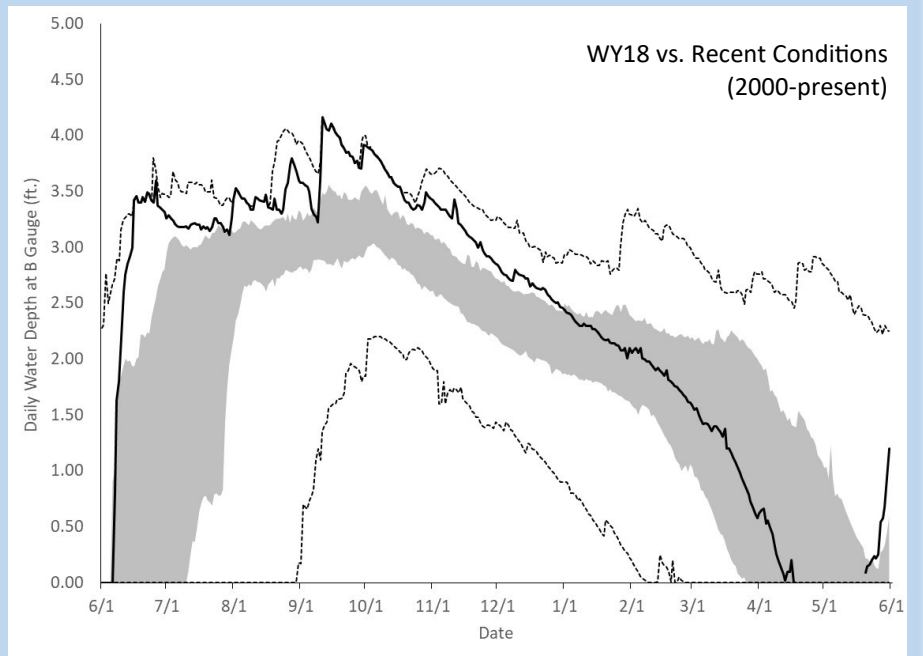
**CURRENT WATER LEVEL:
1.42 ft. (6/1/18)**

May rainfall helped the water level at our B Gauge (North Lettuce Lake) return above ground level on May 20th. Current water levels are described below. More information on the referenced change in hydrology (historic versus recent conditions) can be found on our website (<http://corkscrew.audubon.org/conservation/corkscrew-water-loss>).

— WY18
..... Max & Min
■ Range of 'typical' years
(25th-75th percentile)
